Determination of the windload suction resistance of
Stonel brick surfaced external cladding panel system
according to ETAG 034

Requested by Stonel Oy
Ahlmaninkatu 2 E
40100 Jyväskylä

Assignment **Determination of the windload suction resistance of Stonel brick surfaced external cladding panel system according to ETAG 034**

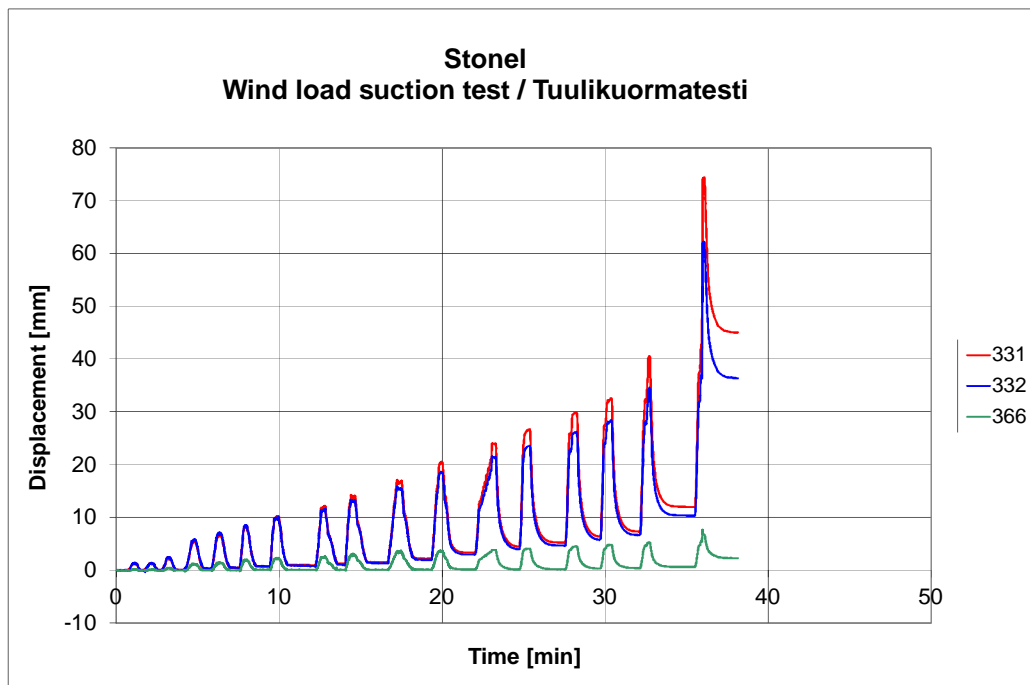
Figure 2. Displacement at measurement points 331, 332 and 336 during windload suction test.

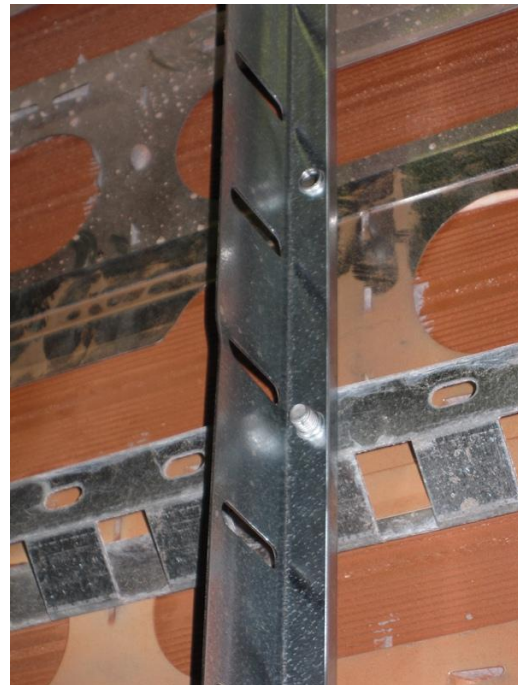
The cladding brick element wall and its fixing part behaved very elastically up to 2600 Pa and the measured residual deflections were below three mm. However, after loading pulse of 2600 Pa there was a slight mark indicating that failure starts with the buckling of the web of the vertical fixing rail. After pulse of 2800 Pa there was permanent deflection in the vertical rail. At greater load pulses the measured maximum and also residual deflections increased gradually showing the above mentioned buckling behaviour and permanent signs of the buckling were clearly seen in the web of the vertical rails.

Photo 4. Start of failure with buckling of web of vertical rail.

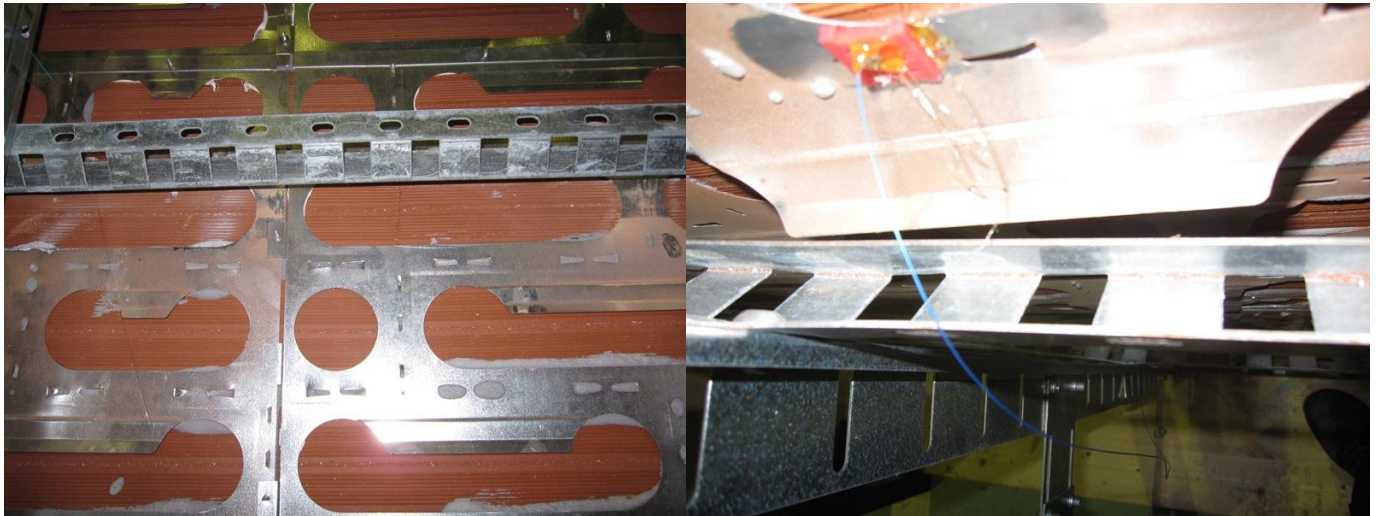
At load pulse of 3200 Pa a vertical crack appeared into upper part of the brick element wall. At 3400 Pa the vertical crack of the brick wall increases. Also there were some permanent deflections also in the horizontal fixing rails.

The final failure of the cladding wall was reached at 3200 Pa when the load pulse of 3600 Pa was tried. The final deflections increased in the vertical and in the horizontal fixing rails and the cladding brick element was broken in so called "envelope" manner. The deflections noticed in the test are presented as a load/time-deflection curves in Appendix 2. Some photos of tests arrangements and of tests are presented in Appendix 3.

Photo 5. Vertical crack in upper part of element at load pulse 3200 Pa.

Photo 6. Final failure. Horizontal rail deformed and element partly loosened from horizontal fixing rail.

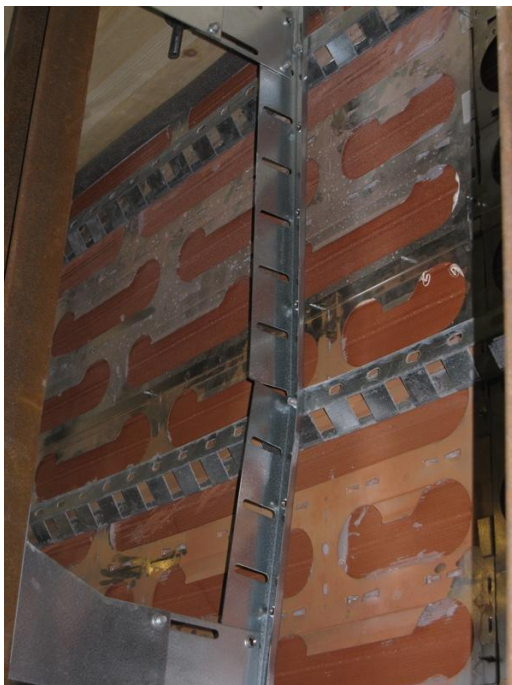
Photo 7. Deformed vertical rail after final failure.

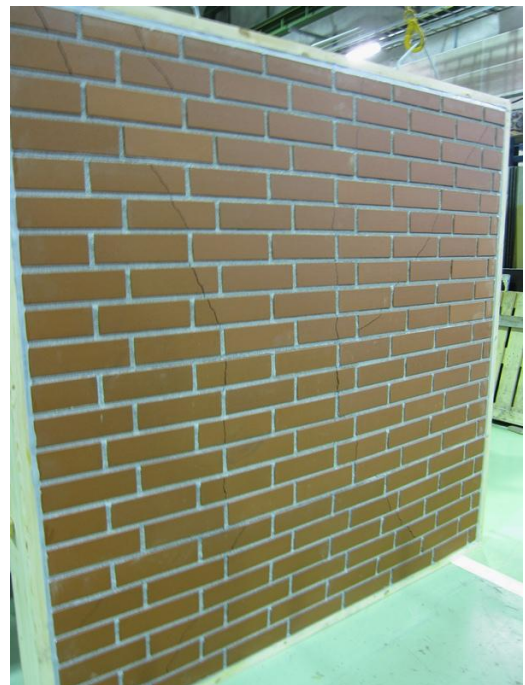
Photo 8. Envelope failure type of brick element.
